TECHNICAL NOTE

**TRUE ADVANCED PURGE™ MODEL TAP-G3
RECENT ISSUES AND RESOLUTIONS**

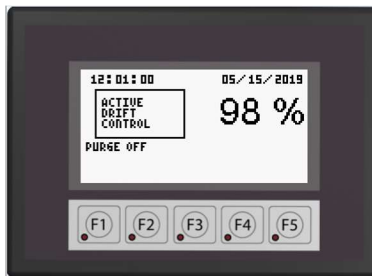
**Model TAP-G3 Display Screen
Shown In ACTIVE DRIFT CONTROL™ Mode**

Issue – During the nightly automatic drift control (ADC™) procedure, users monitoring the **Model TAP-G3** fault contacts with a BMS or fire alarm system were receiving fault signals considered a nuisance when there was no actual fault.

Resolution – **UNITED Fire Systems** has updated the **Model TAP-G3** firmware to disable operation of fault contacts K1 and K2 during ADC™. Normal operation of the contacts is re-enabled after the automatic procedure is complete. The following table appears in Manual P/N 33-TG3MAN-000 Revision 1.01 on Page 9.

Model TAP-G3 devices manufactured on and after 11 Mar 2024 will be factory-programmed with this updated firmware. Devices manufactured before that date can be field-updated by **UNITED Fire Systems** for users requiring this feature. Contact **UNITED Fire Systems** for service.

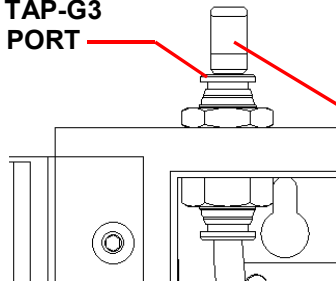
MODEL TAP-G3
INLET PORT

Issue – Installers have observed on occasion that debris has entered the sensor chamber of some **Model TAP-G3** devices. **UNITED Fire Systems** believes such debris entered the devices during installation. While the debris at this time has not resulted in inaccurate nitrogen purity readings or premature sensor failure, **UNITED Fire Systems** believes the entry of debris should be prevented.

PLUG – REMOVE JUST PRIOR TO
ATTACHMENT OF TUBING

Resolution 1 – To avoid debris entry directly into the **Model TAP-G3** inlet port, **UNITED Fire Systems** now installs a plug into the port at the time of assembly.

Keep the factory-installed plug in the port throughout and after the installation process. Remove the plug only immediately before attaching the sampling tubing to the port. Discard the plug after removal.

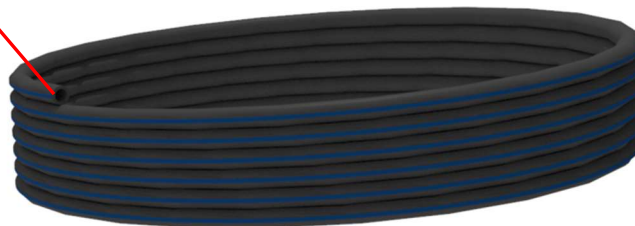
LENGTH OF
SAMPLING
TUBING

REMOVE CAPS
JUST PRIOR
TO INSTALLATION

Resolution 2 – To avoid debris entry into sampling tubing during installation, **UNITED Fire Systems** now attaches caps to each end of the tubing at the factory.

Keep the factory-attached caps on the tubing ends throughout and after the installation process. Remove the caps only immediately before attaching the tubing as needed. Discard the caps after removal.
