TECHNICAL NOTE

**TRUE ADVANCED PURGE™ MODEL TAP-G3
RECENT ISSUES AND RESOLUTIONS**

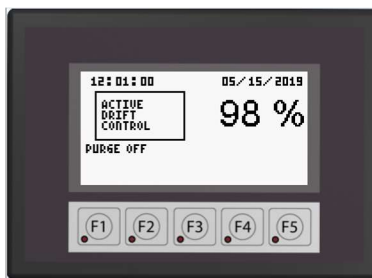
Issue – During the nightly automatic drift control (ADC™) procedure, users monitoring the **Model TAP-G3** fault contacts with a BMS or fire alarm system were receiving fault signals considered a nuisance when there was no actual fault.

**Model TAP-G3 Display Screen
Shown In ACTIVE DRIFT CONTROL™ Mode**

Resolution – **UNITED Fire Systems** has updated the **Model TAP-G3** firmware to disable operation of fault contacts K1 and K2 during ADC™. Normal operation of the contacts is re-enabled after the automatic procedure is complete. The following table appears in Manual P/N 33-TG3MAN-000 Revision 1.01 on Page 9.

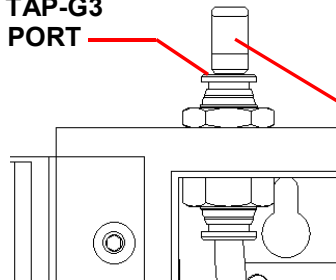
**MODEL TAP-G3
INLET PORT**

Issue – Installers have observed on occasion that debris has entered the sensor chamber of some **Model TAP-G3** devices. **UNITED Fire Systems** believes such debris entered the devices during installation. While the debris at this time has not resulted in inaccurate nitrogen purity readings or premature sensor failure, **UNITED Fire Systems** believes the entry of debris should be prevented.

**PLUG – REMOVE JUST PRIOR TO
ATTACHMENT OF TUBING**

Resolution 1 – To avoid debris entry directly into the **Model TAP-G3** inlet port, **UNITED Fire Systems** now installs a plug into the port at the time of assembly.

Keep the factory-installed plug in the port throughout and after the installation process. Remove the plug only immediately before attaching the sampling tubing to the port. Discard the plug after removal.

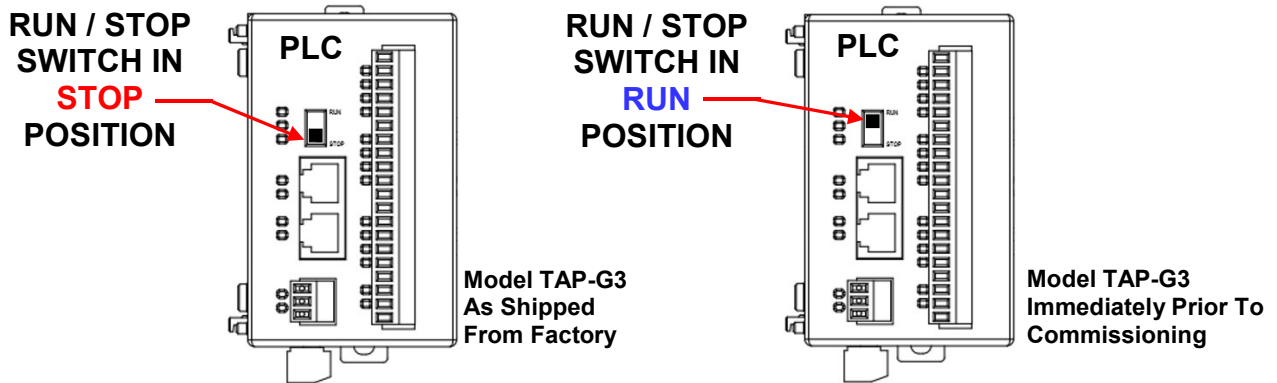
Issue – Several users have observed that their **Model TAP-G3** HMI (Human-Machine Interface) screen has turned a pinkish hue. **UNITED Fire Systems** has determined that this phenomenon occurs when the **RED** flashing of the screen during a fault has been allowed to continue for a very extended period of time.

Resolution 1 – Up to now, connecting live 115 VAC power to the **Model TAP-G3** device far in advance of commissioning has resulted in **RED** flashing for a long period. To prevent this flashing, **UNITED Fire Systems** is now leaving the PLC (Programmable Logic Controller) in **STOP** mode after factory testing.

Place the PLC **RUN / STOP** switch into the **RUN** position ONLY immediately prior to commissioning.
